How do I?

This week: SSTVWhat happened?

Today, let's take a look at why some images may not be so great.

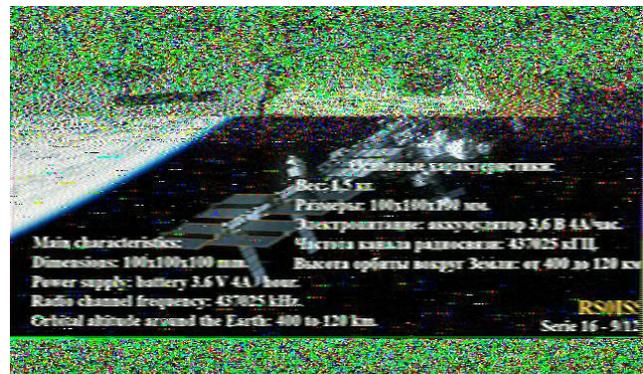
Picture 4 (Above)
2020 10/5 2345

The next pass had some results I didn't expect. Just two images. The first image (Picture 4) is from the beginning and the photo was being transmitted when the ISS came into range, so it is a good example of receiving just the tail end of a transmission.

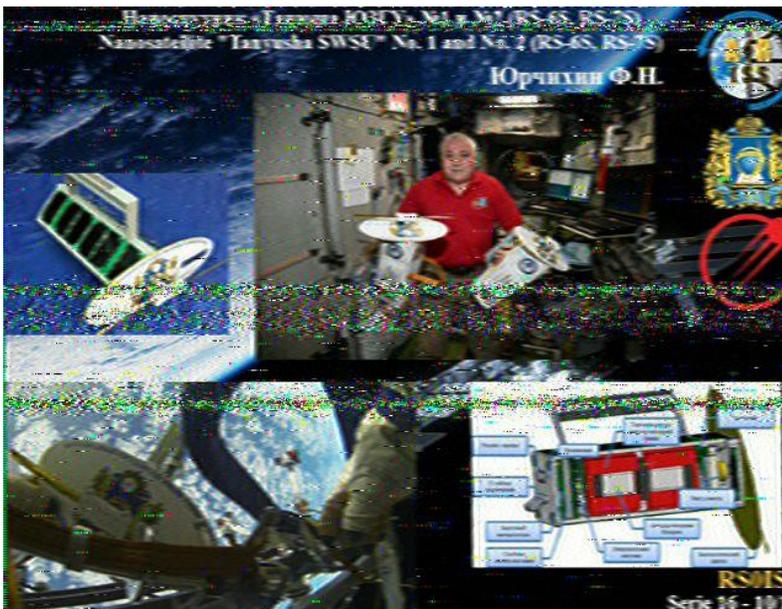
Picture 5 (Left)
2020 10/5 2351

The second image (Picture 5) is from 6 minutes later and is nearly perfect.
